Accessibility Site Survey

LOCATION	WITHHELD
FACILITY PURPOSE	Evacuation Assistance Center for radiological event
ADDRESS	WITHHELD
FACILITY POC PRESENT	Yes
NAME OF ASSESSOR	Dawn Brantley, ADAC, VDEM Sheltering Coordinator
ASSESSMENT TOOL USED	US DOJ ADA Checklist for Emergency Shelters
DATE OF ASSESSMENT	June 2017

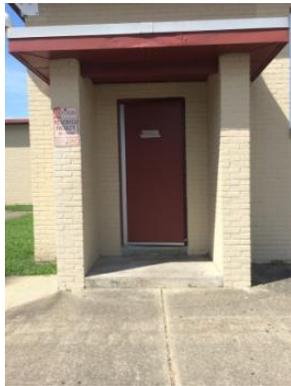
A1.	Is there a sidewalk connecting the parking area and any drop off area to the walkway leading to the building? [ADA Standards § 4.1.3(1)]	Yes	
A2.	Is there a route without steps from this sidewalk to the main entrance?	Yes & No	There are no steps leading into the main entrance for individuals deemed clean. However, all entrances into the locker rooms (decontamination areas) have steps.

Curb ramp near main entrance.

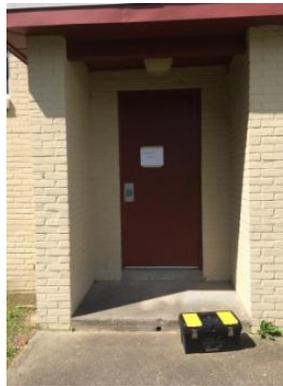
Entrances to men's and women's decontamination areas.

- If locker room doors are wide enough, these would need to be propped open.
- These entrances will need to be ramped.

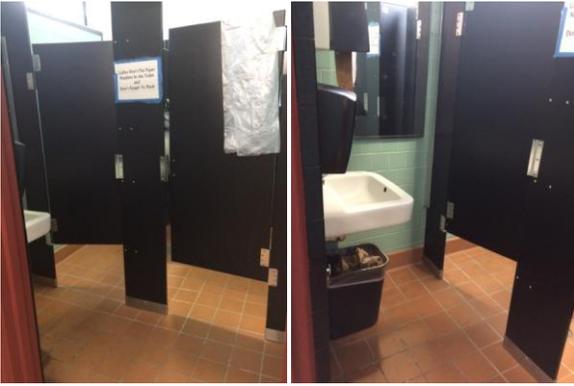
C1-a.	Is there an area within the toilet room where a person who uses a wheelchair or mobility device can turn around – either a minimum 60 inch diameter circle or a “T”-shaped turn area? [ADA Standards §§ 4.22.3; 4.2.3, Fig. 3]	Not measured & No	The distance between the stall wall and the sink in the girls’ locker room is only 18”. In the ladies restroom across from the gym, there is substantial space but it was not measured.
C1-b.	Is at least one stall at least 60 inches wide and 56 inches deep (wall mounted toilet) or 59 inches deep (floor mounted toilet)? [ADA Standards § 4.17.3]	Yes & No	In the ladies restroom across from the gym, 1 stall was wide. The railings were not measured. The girls’ locker room has no accessible stall

Toilet stalls/area in women's decontamination area (girls' locker room).

- None possible due to necessary flow for decontamination.

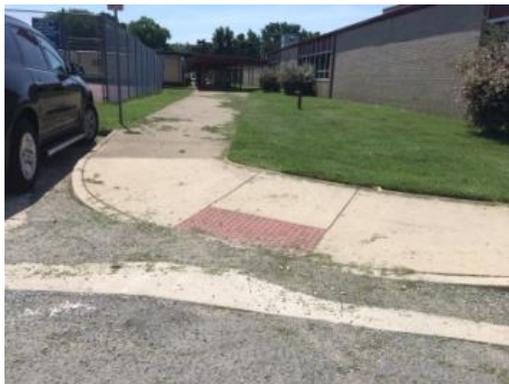
Description: Evaluated one drop off areas for evacuees. Did not evaluate the "Dirty" holding lot area. The drop off area (pull up area) does have a curb ramp but does not have any access aisles. This may be adequate for the purpose of an EAC *if* no paratransit vehicles are used; however it is unknown if Dominion and the locality plan to use paratransit until the plan is reviewed. Additionally, the pull up area had significant amounts of gravel which could cause a safety hazard for individuals with a mobility challenge.

A1.	Is a relatively level (1:50 or 2% maximum slope in all directions) access aisle provided adjacent and parallel to the side of the vehicle pull-up area? [ADA Standards § 4.6.6]	No	There is a curb ramp but no access aisle.
A2.	Is the vehicle pull up area relatively level (1:50 or 2% slope in all directions)?	Yes	
A3.	Is the area for the access aisle at least 5 feet wide and 20 feet long? [ADA Standards § 4.6.6]	No	No access aisle at the drop off point; sidewalk only
A4.	Is there vertical clearance of at least 114 inches (9 feet 6 inches) from the site entrance to the vehicle pull-up area, the access aisle, and along the vehicle route to the exit?	Yes	
A5.	Is a curb ramp provided between the vehicle pull up area and the access aisle or the access aisle and the accessible route to the entrance?	No	The curb ramp is between the pull up area and the sidewalk; no access aisle
A6.	If a curb ramp is provided, is the running slope of the	Not

Curb ramp at drop off point.

- Pull up and drop off area should be cleared of gravel and other debris.

- Measure curb ramp slope.
- Review plan and determine need for accessible aisle.

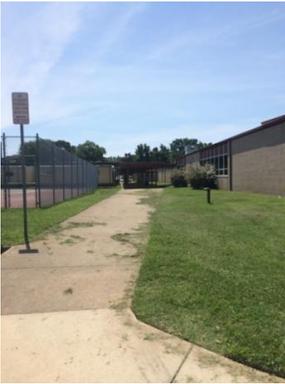
Walk way to portal monitor.

- Rain will impact anyone using a power wheelchair. The city will need to provide an alternative drop off point or provide cover from the rain.

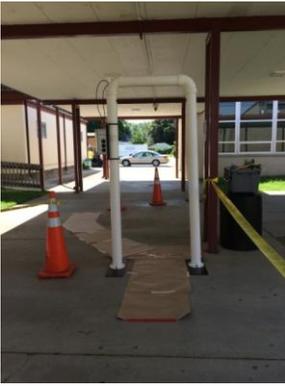
Description: The portal monitor is set up along a smooth route and there will be adequate room for individuals using wheelchairs too large to go through the monitor to navigate around it. It is important to note that the portal monitor set up at this high school was only 31” wide, which does not meet the standard for doorways. As such, most individuals with wheelchairs will need to go around the monitor and be assessed with a handheld device. During set up, the locality will need to ensure the portal monitor is set far enough to one side of the sidewalk to provide 36” of sidewalk (not grass) around the monitor. The brown paper coverage will also need to be added to this route.

Portal monitor.

- Align the portal monitor to one side of the sidewalk and provide brown paper coverage around the monitor.
- Consider shortening the distance and alternative routes during wet weather.

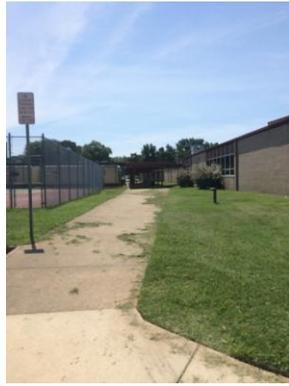
The distance from the drop off area to the monitor and on to the building entrances is significantly long for individuals who have a difficult time with mobility. It is approximately 150 steps from the portal monitor to the female locker room entrance. This does not include the distance from the drop off point to the portal monitor. The locality should consider shortening the distance, if possible. Also, the route is only partially covered which will make the route inaccessible for individuals using power wheelchairs during wet weather.

Walk way to portal monitor.

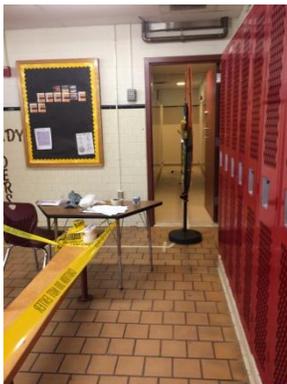
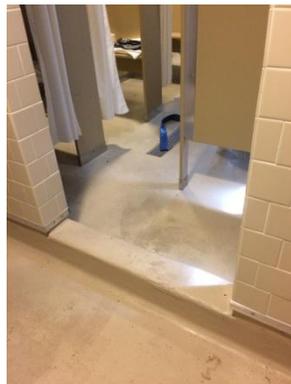
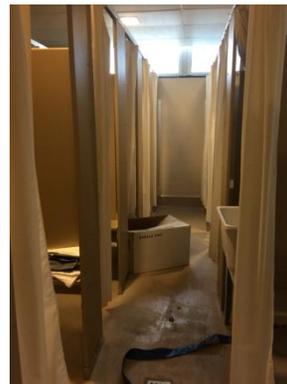
The girl's locker room is not usable as a decontamination area. The toilet stalls used for changing out of contaminated clothing is totally inaccessible to individuals using wheelchairs. Individuals must access the showers in the high school, however the hallway leading to the showers presents several problems. First, the hallway is 44" wide with a 32" doorway. The hall is divided into a dirty lane and a clean lane; each is only 22" wide. Second, at the end of the hallway, individuals must make two left turns and a right turn to access the aisle way between shower stalls. There is not adequate room for anyone using a wheelchair to make those

turns. Third, the entrance to the shower area, at the end of the hallway, has a 6 ¾” ledge that cannot be ramped rendering it inaccessible to individuals using mobility equipment. Fourth, the access aisle way for the showers is 30 ¾” wide and the entry to the stalls is only 21 ¾” wide. Without access to the toilet stalls or the showers, individuals using wheelchairs or some other mobility equipment cannot be decontaminated.

Hallway to shower area. Ledge at entrance to showers. Aisle between shower stalls.

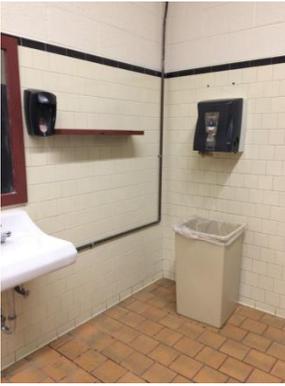
H14.	Are all built-in dispensers, receptacles, or equipment mounted so the front does not extend more than 4 inches from the wall if the bottom edge is between 27 inches and 80 inches above the floor?	No	The paper towel a and soap dispensers extend 10.5" from the wall.

Girls' restroom across from gym.

- Trash cans will need to be moved out of the approach pathway.
- Something will need to be placed underneath paper towel and soap dispensers to make them cane-detectable.

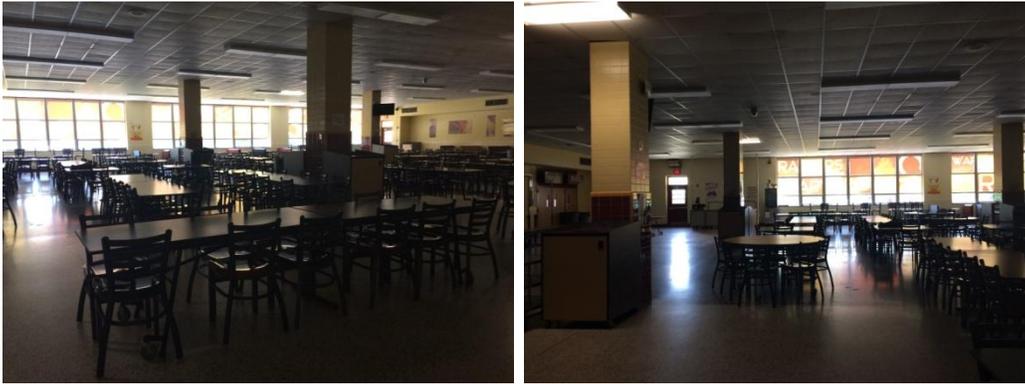
Description: The eating area is a large cafeteria on the opposite side of the school from the gymnasium. The distance is substantial. The floor is large, smooth tile but was locked at the time of the survey so the area was only superficially visually assessed.

Cafeteria

- Complete assessment of eating and serving areas.
